**REPORT ON THE SCIENTIFIC INVESTIGATION OF THE IMPACT OF
MARANGE DIAMOND MINING OPERATIONS ON WATER QUALITY IN
THE SAVE AND ODZI RIVERS: INCLUDING ASSESSMENT OF THE
HEALTH, ENVIRONMENTAL AND LIVELIHOODS IMPACTS**

ZIMBABWE ENVIRONMENTAL LAW ASSOCIATION (ZELA)

JULY 2012

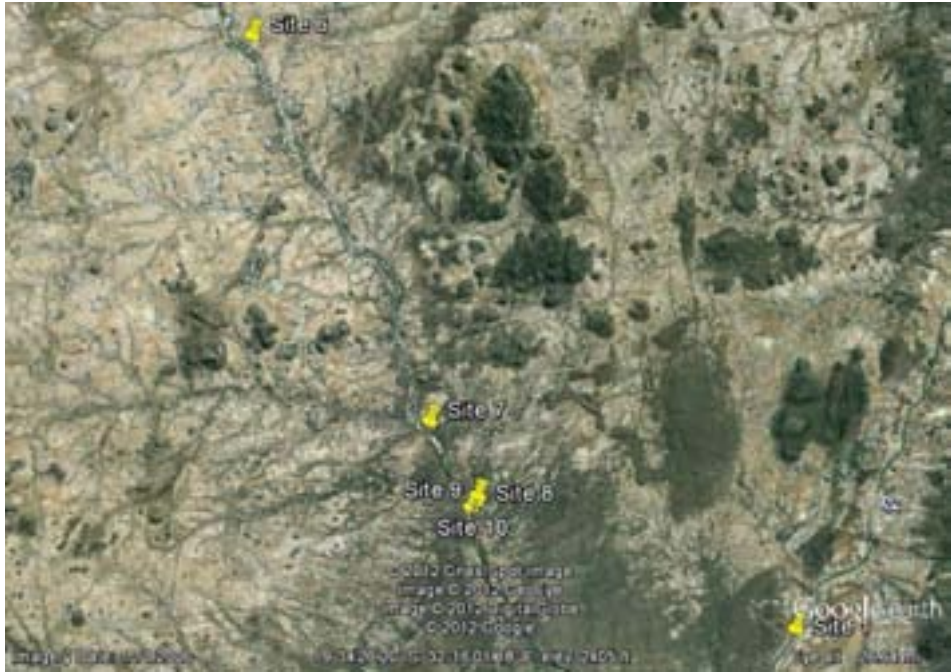
Figure 4. Satellite imagery showing Sites 6, 7, 8, 9 and 10 on the Save River and the discharge from Singwizi River.

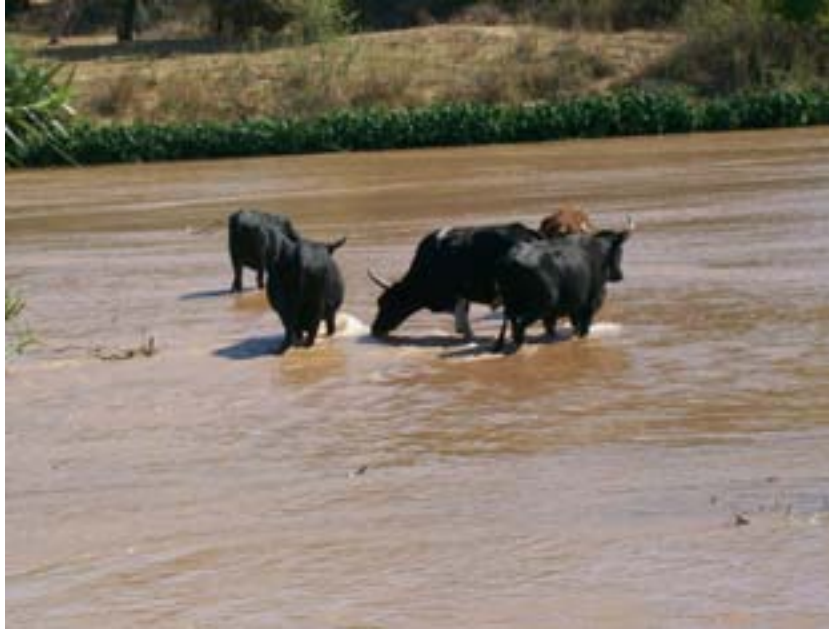
Photo 1. Site 1 on Odzi River near Nenohwe village (5 July 2012).

Site 1: The water was turbid (water was cloudy, opaque, or muddy) because of being discharged at Marange-ANJIN Resources mine. The site is about 5km downstream of the mine. It was not possible to sample the point of discharge because of limited accessibility to the plant. Livestock and people cannot use the water for drinking and any other domestic uses.

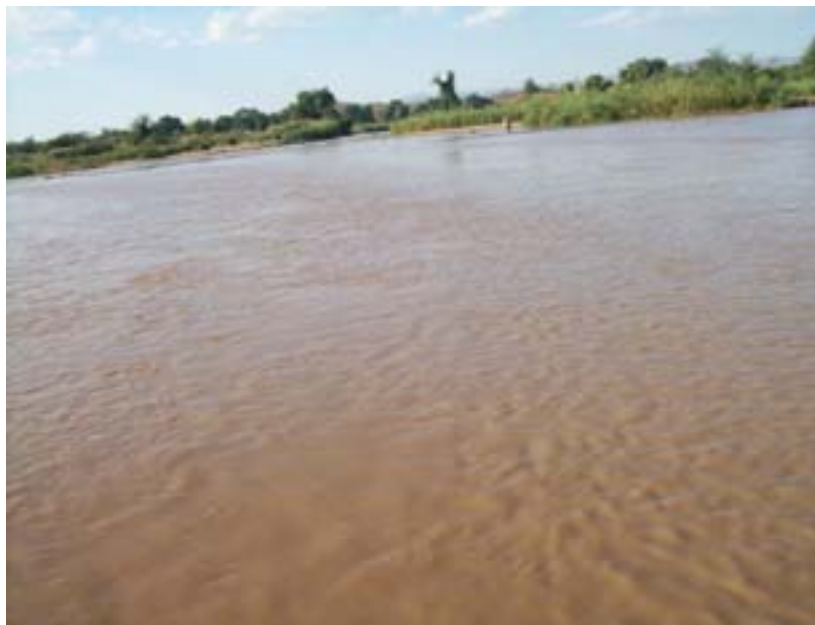
Photo 2. Site 2 on Save River near Nechishanye village but upstream of Odzi/Save confluence (5 July 2012).

Site 2: The water was turbid (water was cloudy, opaque, or muddy) at this site and cannot be used to water livestock or other domestic uses. This site is downstream of the discharges from the mining area especially that of DMC mine.

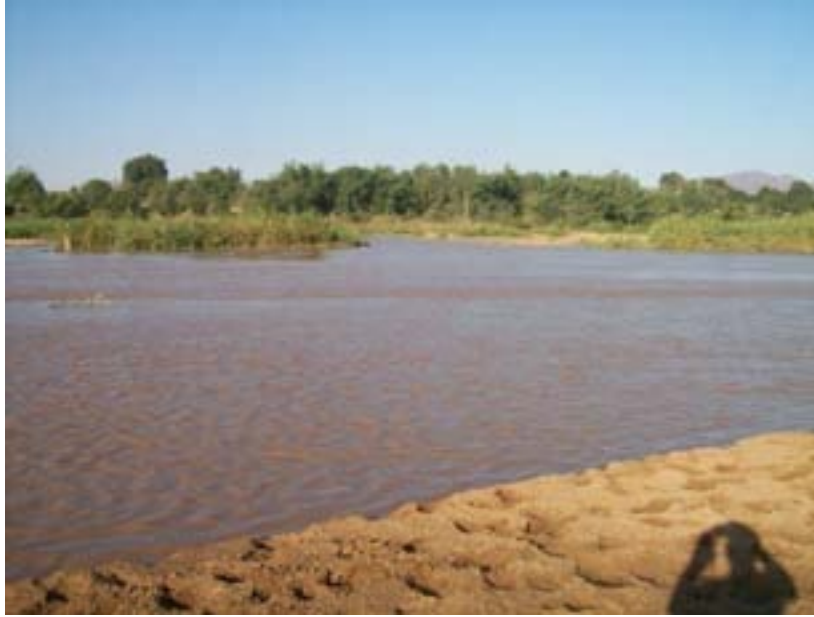
Photo 3. Site 3 near Nechishanye village at the confluence of Odzi and Save Rivers (5 July 2012).

Site 3: The water was again turbid (water was cloudy, opaque, or muddy) at this site and cannot be used to water livestock or other domestic uses. This site is downstream of the discharges from the mining area.

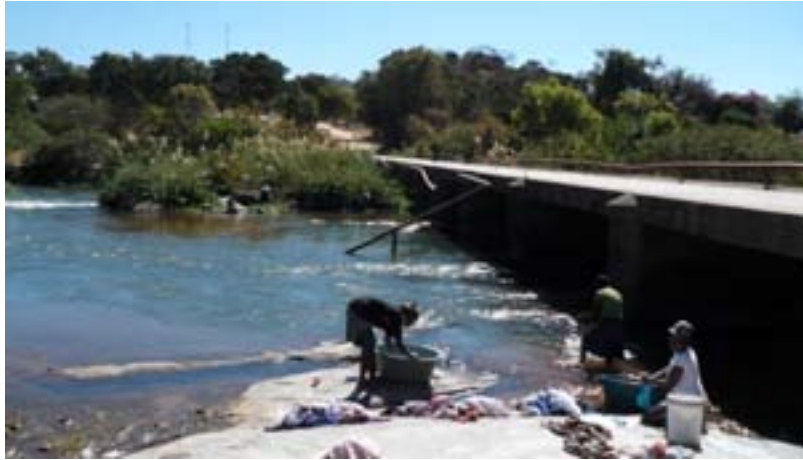
Photo 5. Site 5 at Bazeley Bridge upstream of Anjin Mine and Marange Resources discharge points (6 July 2012).

Site 5: Water was clear at this site at Bazeley Bridge and women were actually seen doing laundry at the site. This site is just upstream of the Marange diamond fields mining area and was the **reference point** for the Odzi River.

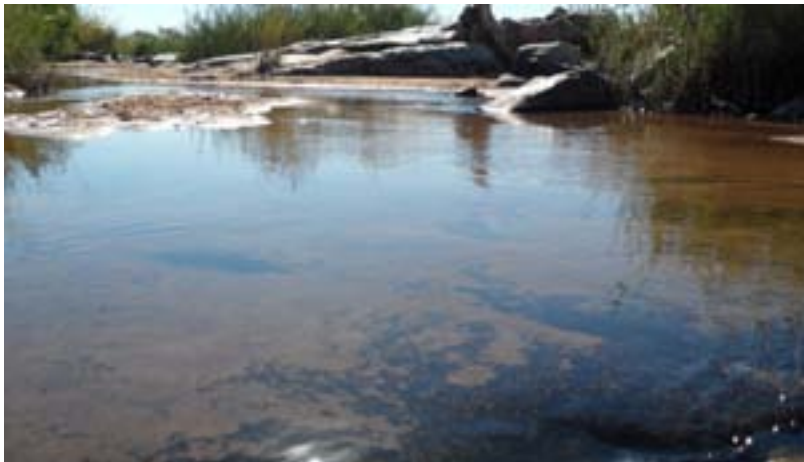
Photo 6. Site 6 at Save River Bridge near Mafarikwa Village in Marange.

Site 6: Water was clear at this site and even fish could be seen swimming in the water. Local people were also bathing and swimming upstream. This site was the **reference point** on the Save River.

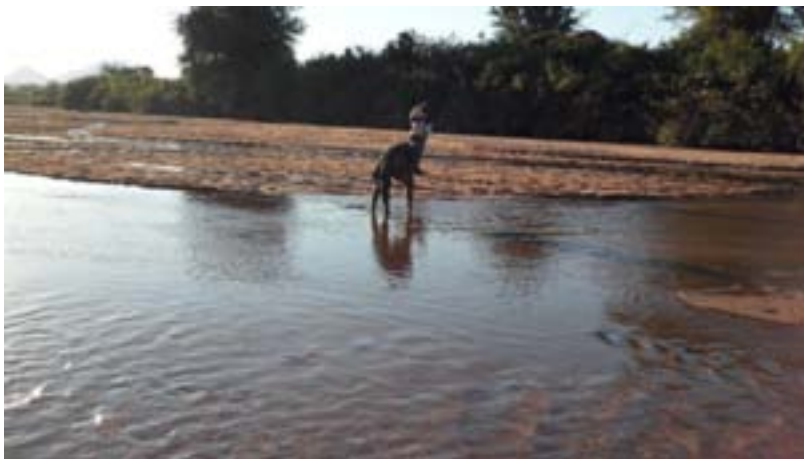
Photo 7. Site 7 on Save River River at Dune/Banda- Maundu Village in Buhera.

Site 7: This site was just upstream of the DMC mine point of discharge where the Singwizi River confluences with the Save River. At this site, DMC mine pumps its water from the Save River, and the return flow from the mine comes back through the Singwizi River. The water was clear and indicated good water quality at this site.

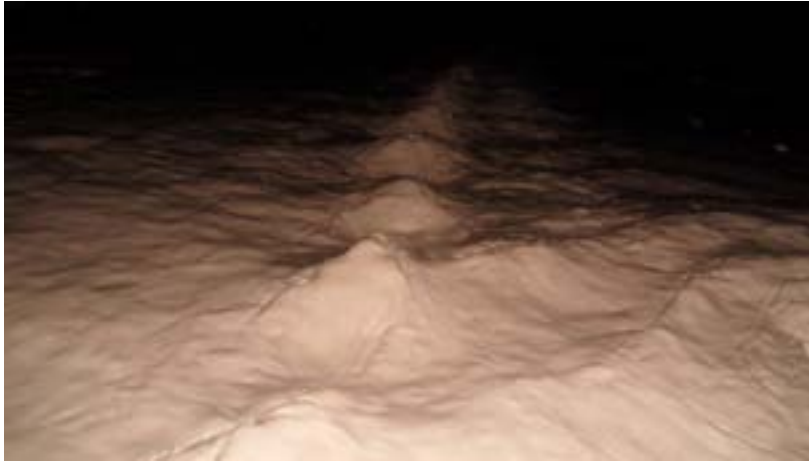
Photo 8. Site 8 on Singwizi River (tributary of Save River) near DMC Mine discharge point in Marange (photograph taken at night).

Site 8: This site is the point of discharge of effluent from DMC mine. The effluent is discharged into a tributary of Save River called Singwizi River just before the point of confluence of the two rivers. The water was very turbid (cloudy, opaque, or muddy) and the river bed was very muddy and sticky. When in contact with the skin, the water and mud was itchy.

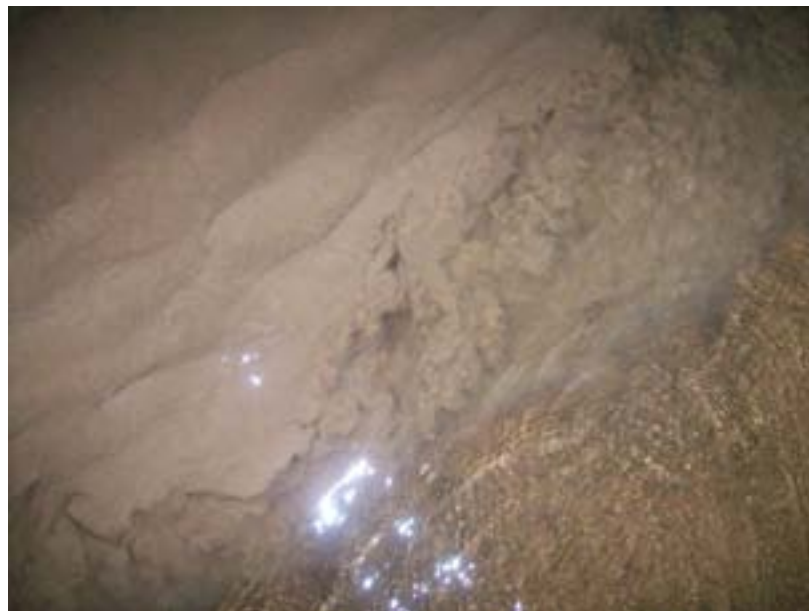
Photo 9. Site 9 at the confluence of Singwizi and Save Rivers (photograph taken at night).

Site 9: This is the point of confluence between Singwizi River and the Save River. At this point the clean water from upstream meets the now dirty, turbid water from Singwizi River. The sample was taken from the braided channel of the Save River that connects with Singwizi River. From the picture, two different waters can be distinguished (**Photo 9**).

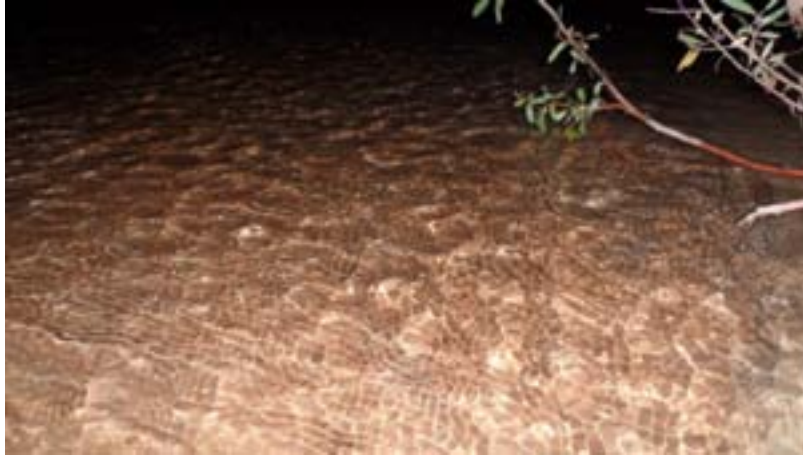
Photo 10. Site 10 on the braided channels of the Save river outside the mining region (photograph taken at night).

Site 10: This site is the point of braiding of Save River. The water sample was taken on the clean side so as to be compared with the point of confluence with Singwizi which will be on the other braid.
